# Recent turbine failures and the root cause

From lapses in manufacturing quality to the introduction of new technologies, wind turbine components are still at risk of costly failures. Determining the root cause of the failure can not only prevent future liabilities for equipment manufacturers and reduce risk for operators but also improve production procedures and industry design standards.

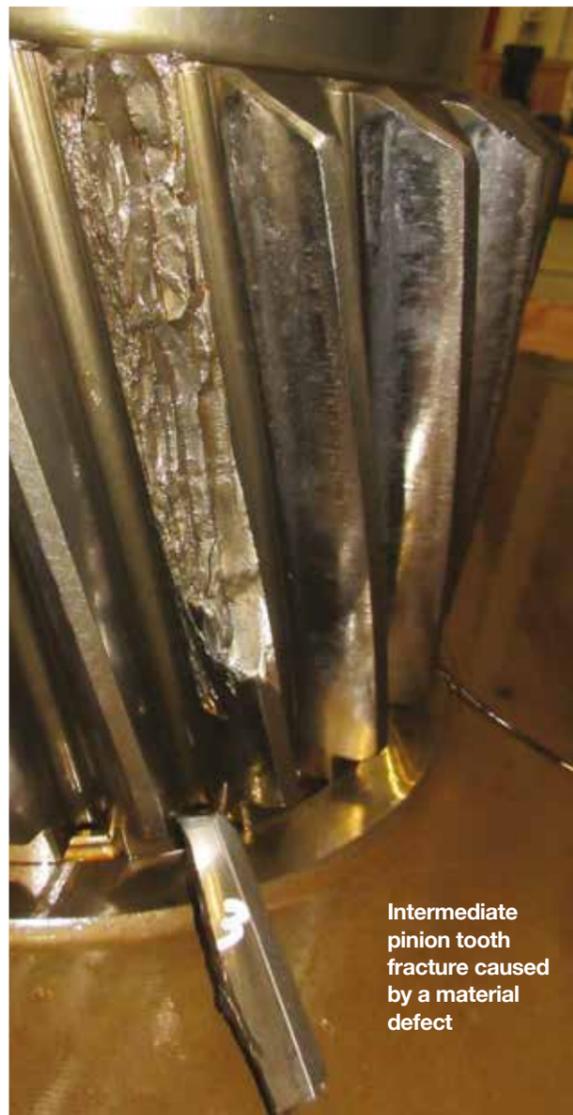
Multiple wind turbine gearboxes had catastrophic intermediate pinion failures during a similar timeframe. Gear tooth fractures resulted in liberated pieces of metal and consequential damage to other components. The gearboxes had been refurbished by an aftermarket supplier other than the OEM and had been in service less than 3 years.

Intermediate pinion tooth fracture caused by a material defect

Metallurgical analysis on cross-sections of the fractured teeth determined that the cracks originated at subsurface material defects. Further testing identified them as oxide inclusions containing aluminium and silicon. During normal cyclic loading the inclusions act as localised stress concentrations which cause cracks to form prematurely. It was determined that the batch of steel used by the gear supplier didn't meet the cleanliness grade.

A gearbox repair specification was established for the suppliers of the refurbished gearboxes which defines that material cleanliness must meet certain standards and gear manufacturing quality control processes must be added using non-destructive testing.

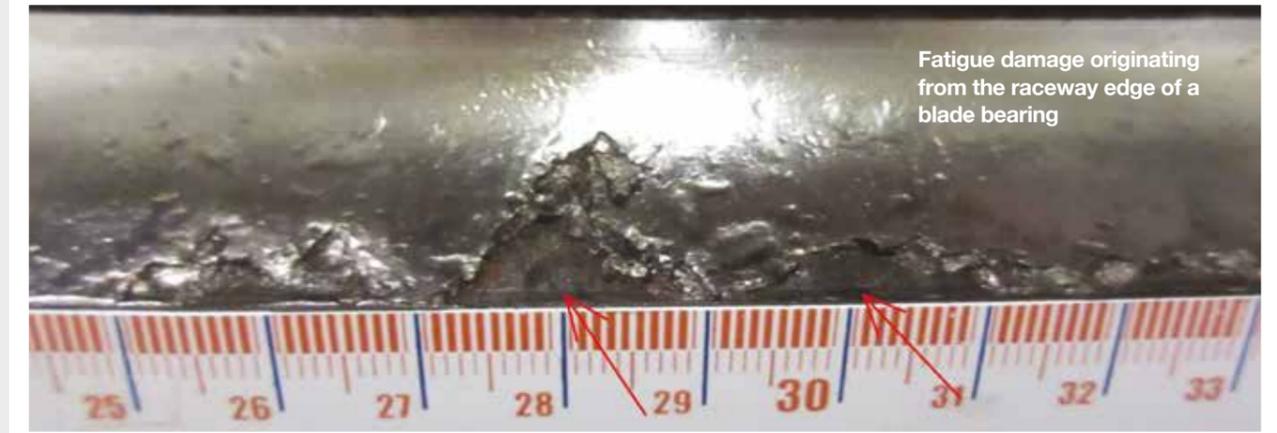
Fatigue damage originating from the raceway edge of a blade bearing

A wind turbine blade bearing was taken out of service due to pitch angle asymmetry. Upon disassembly, the failure was identified as macropitting at the edge of the bearing raceway. Macropitting is a progressive failure mode driven by fatigue of the steel material.

The damage was caused by excessive contact stress at the edge of the raceway where the contact area of the rolling elements had shifted beyond the raceway edge, referred to as 'ellipse truncation'. The increased stress this causes to the components reduces fatigue life, leading to early failure.

Design improvements were made to improve the raceway contact, thus minimising the edge contact stresses during ellipse truncation. This was achieved by stiffening the rings, adjusting pre-load and optimising the micro-geometry of the raceway profile. The failure costs of the installed base can be alleviated by periodic grease sample analysis. Early detection of failures allows forecasting for bearing replacement, thus minimising downtime and crane fees.

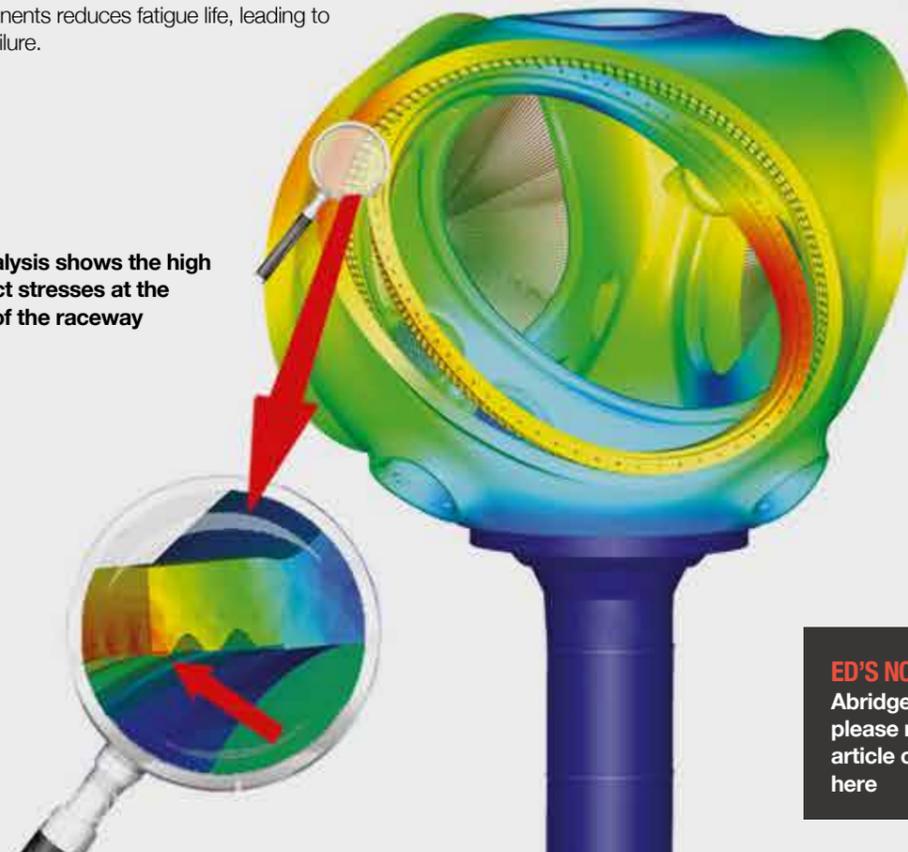
FE analysis shows the high contact stresses at the edge of the raceway
